Corrosion Fatigue Studies on a Bulk Glassy Zr-Based Alloy under Three-Point Bending

Corrosion fatigue (CF) tests were carried out on bulk glassy $\text{Zr}_{52.5}\text{Cu}_{17.9}\text{Al}_{10}\text{Ni}_{14.6}\text{Ti}_5$ (Vitreloy 105) samples under load-controlled three-point bending conditions with a load ratio of $R = 0.1$ in $0.01 \text{ M Na}_2\text{SO}_4 + 0.01 \text{ M NaCl}$ electrolyte. During cyclic testing, the bar-shaped specimens were polarized *in situ* at constant potentials and the current was monitored. Three different anodic potentials within the interval between the pitting potential E_P and the repassivation potential E_R and three different load amplitudes were applied. In some cases, *in situ* microscopic observations revealed the formation of black corrosion products in the vicinity of the crack tip during anodic polarization. Fractographic analysis revealed a clear distinction between two modes of crack growth characterized by smooth dissolution induced regions on the one hand and slim fast fracture areas on the other hand. Both alternating features contributed to a broad-striated CF fracture surface. Moreover, further fatigue tests were carried out under f

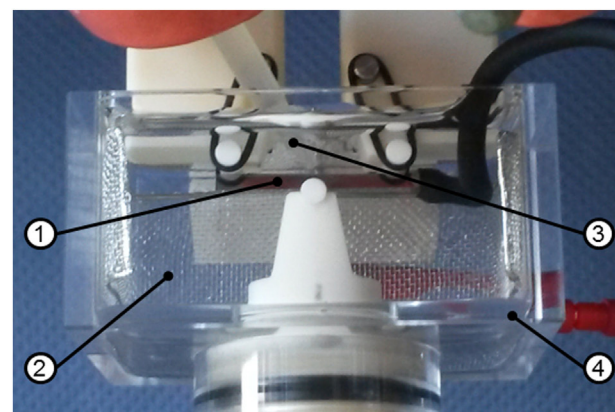
FIGURE 1 | Set-up of the electrochemical cell for corrosion fatigue experiments, including the sample (1) as working electrode, a fine platinum mesh (2) as counter electrode, an agar salt bridge (3) connected to the saturated calomel electrode reference electrode and an acrylic glass container (4) filled with 0.01 M Na_2SO_4 + 0.01 M NaCl .

All three-point bending fatigue experiments were carried out in sinusoidal load control at room temperature ($\sim 22^\circ\text{C}$), a load ratio of $R = \sigma_{\min}/\sigma_{\max} = 0.1$, and a frequency of $f = 5$ Hz on a Schenck servo-hydraulic testing device. The distance between the outer support rolls of the three-point bending mounting was 20 mm and the rolls had 3 mm in diameter. All parts of the mountings were manufactured of a high performance ceramic, Al_2O_3 , to ensure corrosion resistance and electric isolation during electrochemical testing. The polarization tests and measurements of the open circuit potential (OCP) were conducted with a PAR VersaSTAT4 electrochemical interface. The electrochemical cell, which is presented in Figure 1, consisted of the bar-shaped sample as working electrode, a fine platinum mesh as counter

electrode and a [saturated calomel electrode (SCE), $E = 0.241$ V vs. standard hydrogen electrode] as reference. All potential values in this work are referred to this reference electrode. The connection between the electrochemical cell and the reference electrode was achieved by an agar salt bridge-containing 1 M KCl solution for high charge transport.

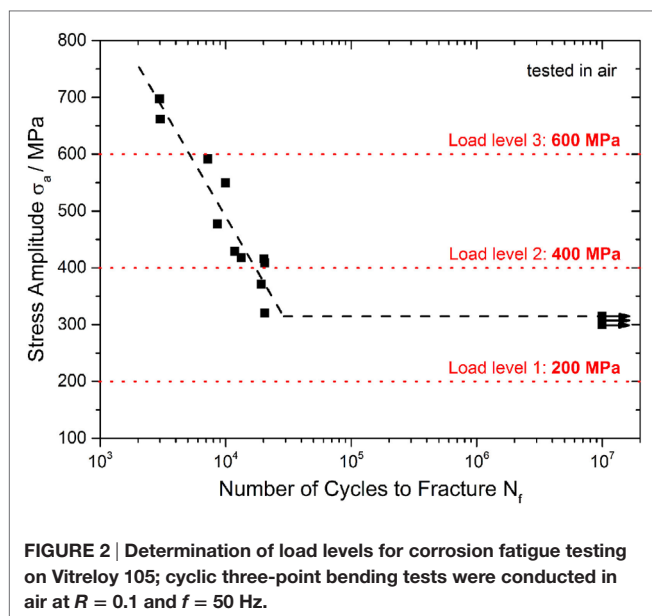
In order to select three load levels for CF tests, the S-N curve of the bulk glassy $\text{Zr}_{52.5}\text{Cu}_{17.9}\text{Al}_{10}\text{Ni}_{14.6}\text{Ti}_5$ alloy was determined in air (Figure 2). The black trend line characterizes the fatigue life of the tested Vitreloy 105 samples, and horizontal arrows denote runouts that endured more than 10^7 load cycles. It should be noted that the real fatigue strength of Vitreloy 105 was determined at $\sigma_a = 315$ MPa. When assuming an ultimate tensile strength

of $\sigma_{UTS} = 1,700$ MPa [only determined for Vitreloy 105 under four-point bending conditions (Morrison et al., 2007b)], there is a normalized fatigue limit of $\sigma_a/\sigma_{UTS} = 0.19$. The load levels for later CF tests were chosen in order to cover an interval of number of cycles to fracture as wide as possible.

of Vitreloy 105 and should be discussed in correlation with the fatigue behavior in air (see S–N curve in **Figure 2**). Although all three selected potentials are located in the anodic regime enabling pitting corrosion [all three potentials are higher than the repassivation potential, i.e., mean value -99 mV vs. SCE, SD 28 mV (Gostin et al., 2015a)], there seems to be a lifetime extending effect of the most negative potential, i.e., -50 mV vs. SCE, and an obviously degrading effect of 0 mV vs. SCE and $+50$ mV vs. SCE, which are closer to the critical pitting potential E_p (Gostin et al., 2015a) compared to the results of the samples tested in air. The fine grading of the chosen potentials offers a much more explicit view on the electrochemical influence of fatigue life than the research of Morrison et al. (2007a) who distinguished only between anodic polarization at 100 mV vs. SCE and cathodic polarization at -900 mV vs. SCE in aqueous 0.6 M NaCl solution. Their research also detected an environmental degradation mechanism only at anodic potentials and concluded that anodic dissolution is responsible for the negative effect. That assumption is in good accordance with the results of our recent CF reference tests in halide-free 0.01 M Na_2SO_4 solution, where no negative effect on fatigue life could be detected. So, we consider the increased pitting propensity in presence of chloride ions to be the driving force during crack propagation.

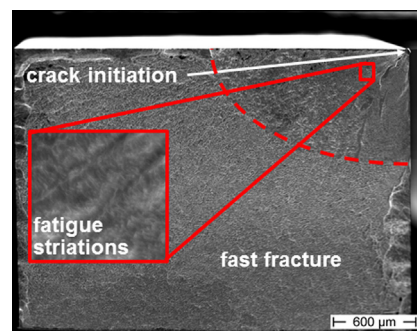
FIGURE 3 | Typical fracture surface of a bar-shaped Vitreloy 105 sample after cyclic three-point bending at $R = 0.1$, $f = 50$ Hz, $\sigma_a = 400$ MPa, and $N_f = 20,550$ in air (tensile loaded surface is at the top, detailed view of striated fatigue region showed in red inset).

Fractographic analysis of samples fractured in air revealed characteristic features of Zr-based BMG fracture surfaces as also detected in Hess et al. (2006) and Morrison et al. (2007b). **Figure 3** shows a representative fracture surface of the three-point bending fatigue samples. Cracks were found to initiate at the tensile stressed surface, especially at sample edges starting from small surface defects or sometimes at near-surface micropores that act as supplementary stress concentrators (not shown here). Stable crack growth occurred in the quarter-elliptic fatigue region that is characterized by fine striations (see red inset in **Figure 3**) that result from stepwise crack propagation along small shear bands arising in the plastic zone in front of the crack tip. However, crack propagation could not be correlated directly to striation spacing, which suggests that there is an accumulation of damage over several loading cycles as also reported by Liu et al. (2015). The area of fatigue crack growth covered between 6 and 35% of the whole fracture surface in the present study. After passing a sharp transition region, the crack propagates much faster until final fracture occurs. The resulting fast fracture region has a characteristic vein-like morphology, which is commonly observed in BMGs.

explained by a varying sample quality. Fracture can be influenced by micropores with sizes up to $50 \mu\text{m}$ as well as by other material imperfections (e.g., unmolten particles). The formation of such defects during the suction casting process could not be avoided completely. Both features led to a shifting of the crack initiation site from the tensile-stressed surface to inner regions in some cases, and this could also be detected on the fracture surface.

Besides the bending fatigue samples tested in air, which showed the characteristic features on their fracture surfaces (see **Figure 3**), the polarized samples have also been investigated by SEM. The observed fractographic characteristics are presented exemplarily in **Figure 7** on a CF sample tested at $\sigma_a = 388$ MPa and an anodic potential of 0 mV vs. SCE.

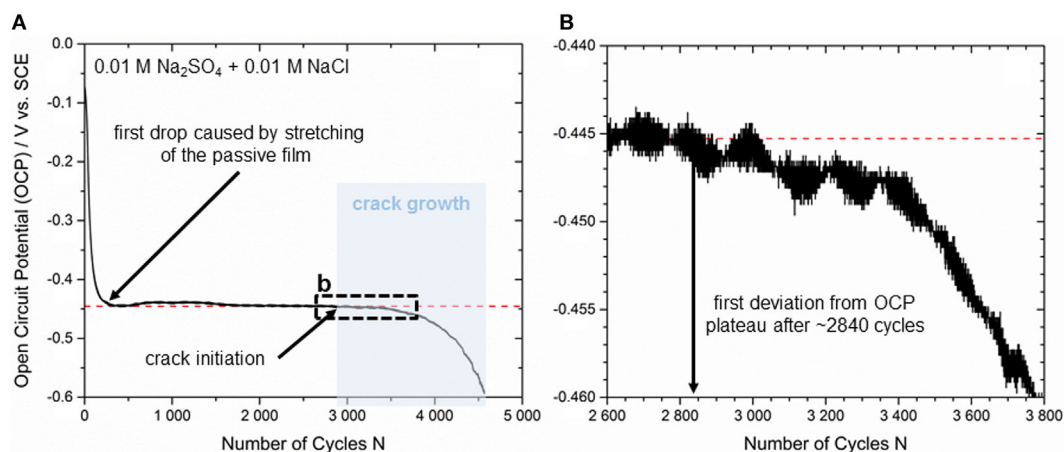
FIGURE 4 | (A) Crack initiation and propagation correlated to an *in situ* OCP measurement during cyclic three-point bending at $\sigma_a = 541$ MPa and **(B)** detailed view of the earliest stage of crack initiation (black dashed box).

Before mechanical testing was started, the bending samples have been immersed in $0.01 \text{ M Na}_2\text{SO}_4 + 0.01 \text{ M NaCl}$ solution for 45–60 min until the changes in OCP were less than $2 \text{ mV}/5 \text{ min}$. According to that, OCP was in a steady state (mean value from all tests $\sim 165 \text{ mV}$ vs. SCE) when the first loading cycle was applied. Since the mechanical pre-load to ensure exact positioning of the samples in the three-point mounting was set to only $\sim 50\%$ of the maximum stress prior to cyclic loading, there was a significant drop in OCP from $-74 \pm 5 \text{ mV}$ vs. SCE to $-445 \pm 5 \text{ mV}$ vs. SCE when the test started, and the maximum load was achieved for the first time. This effect is caused by a sudden stretching of the passive

layer as a consequence of extended flexure on the tensile loaded surface. Subsequently, repassivation started and there is a slight but steady increase visible in the OCP curve. Because of the high sensitivity of the electrochemical set-up and as a result of small vibrations in the corrosion cell during cyclic loading, there is a little deviation in OCP until a significant plateau at -450 ± 10 mV is reached (see red dotted line in **Figure 4A**). Our results are also in good agreement with the observations of Morrison et al. (2007a) as the plateau levels are supposed to depend on the loading level. Cyclic testing at $\sigma_a = 400$ MPa led to a steady OCP value of -300 ± 10 mV vs. SCE, while testing at $\sigma_a = 650$ MPa generated an OCP value of -500 ± 10 mV vs. SCE. However, the first deviation from the stable plateau in terms of a smooth drop of the OCP is detected after $2,840 \pm 10$ loading cycles (see **Figure 4B**) for the presented sample. This drop indicates the earliest stage of crack initiation at the tensile-stressed sample surface. It can be assumed that the OCP changes immediately since in the crack region the bare metal surface is exposed to the electrolyte. A continuous decrease in OCP characterizes the following stable crack growth section (**Figure 4A**, marked in blue), which can be correlated to stable fatigue crack propagation detected by fine striations on the fracture surface. Further small drops in OCP are supposed to be related to locally increased crack growth velocity before crack tip blunting delays crack propagation. The OCP signal decreases until sample fracture after $4,530 \pm 10$ cycles, and therefore, the section of stable crack growth is suggested to be $(4,530 - 2,840) / 4,530 \approx 37 \pm 1\%$ of the whole fatigue life. An additional analysis of the equivalent fracture surface (not shown here) reveals a fatigue crack region of 0.53 mm^2 delivering a fraction of only $11 \pm 1\%$ with respect to the total cross section of 4.76 mm^2 . Furthermore, the rate of decrease (or the slope) of the OCP curve increases uniformly as expected in accordance with increasing crack growth velocity. As the stable crack growth regime determined by the OCP analysis is significantly larger than the fatigue fraction at the fracture surface, we suppose that the highly sensitive electrochemical response also considers early

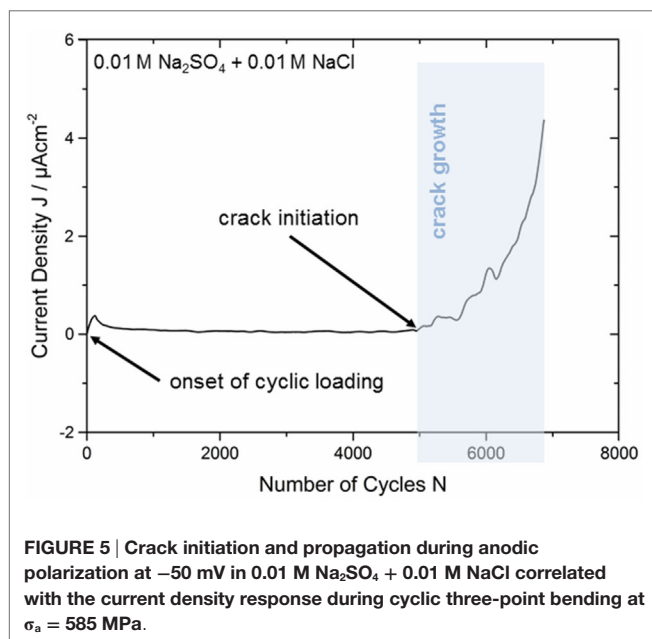
When applying a potential of -50 mV vs. SCE, the current density establishes at a nearly constant value slightly above $0 \text{ } \mu\text{A cm}^{-2}$ due to almost equal cathodic and anodic currents as expected in a regime so close to the corrosion potential. This steady state was achieved after ~ 200 s, and mechanical loading was started subsequently. Due to the onset of cyclic loading, the current density shows a sharp peak (see **Figure 5**) and this is attributed to the stretching of the passive layer as described for the OCP measurements in Section "Crack Growth Analysis by OCP Measurement" above. This is followed by a continuous decrease until a second plateau is attained at $\sim 0.2 \text{ } \mu\text{A cm}^{-2}$. The current density remains at a nearly constant level, which is

slightly above the value in the mechanically unloaded regime because the passive film is constantly altered by the cyclic stress. Since the scatter in the current density curve is very small, the point of passive film breakdown can be detected quite exactly after $4,880 \pm 10$ loading cycles. Thereby, the fatigue crack initiates at the tensile stressed sample surface and breaks the passive layer locally. Then, the current response starts to increase steadily as a result of stable crack propagation and related local metal dissolution. Several sudden current drops occur and these phenomena may be related to variations in the crack growth rate and short-term delay of crack propagation. Shear banding processes in the plastic zone in front of the crack tip are expected to cause crack tip blunting, and multiple shear bands can lead to changes of the crack path until the sample finally failed after $6,885 \pm 10$ loading cycles. Such a delayed crack growth was also detected for bainitic and martensitic steels by Suresh et al. (1981). They observed the generation of oxide films within the crack during mechanical testing at low loading ratios ($R = 0.05$) in moist atmospheres. In case of small crack tip opening displacements that are present especially at early fatigue fracture stages, these oxide layers lead to an earlier contact between both crack surfaces. As a consequence, the authors suggested a raise in the critical stress intensity factor K_c and a reduced effective ΔK in the crack tip region. Due to comparable testing conditions, a similar mechanism could be supposed in our current investigation on Zr-based bulk metallic glass. However, oxidization processes within the propagating crack as a result of repassivation events should be clearly detectable by drops in the current response (see stable crack growth regime in **Figure 5**). The fraction of stable fatigue crack propagation related to the number of cycles to failure is $29 \pm 1\%$ and thus $\sim 21.6\%$ lower than the fraction determined at comparable stresses by *in situ* OCP analysis in Section “Crack Growth Analysis by OCP Measurement.” However, it should be noted that fatigue life could be extended by more than 50% due to anodic

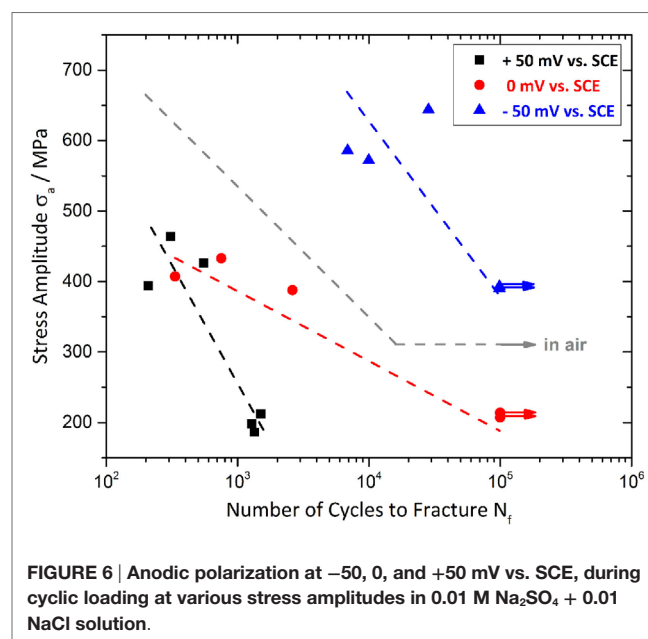
The results in **Figure 6** reveal a distinct influence of the stress level as well as of the applied anodic potential on the fatigue life

Our results reveal a mean number of cycles to failure of $18,290 \pm 10$ in air, 375 ± 10 cycles at $+50$ mV vs. SCE, $1,234 \pm 10$ cycles at 0 mV vs. SCE, and two runouts for -50 mV vs. SCE (all tests around $\sigma_a = 400$ MPa). Therefore, a superimposed effect of both anodic dissolution and repassivation processes at the crack tip is suggested to influence CF behavior of Vitreloy 105 essentially with the predominant effect depending on the selected anodic potential. Consequently, -50 mV vs. SCE is slightly more noble than the repassivation potential $E_R = -99$ mV vs. SCE meaning a lower tendency to anodic dissolution and increased repassivation tendency preventing the sample from fracture within 10^5 loading cycles. The fact that even longer fatigue lifetimes than in air were detected at -50 mV vs. SCE could be explained by an oxide-induced crack closure, which was already described above (Suresh et al., 1981). Whereas, anodic polarization at $+50$ mV vs. SCE is passing closer to the pitting potential of $E_p = 297$ mV vs. SCE and reinforces the creation of corrosion pits and anodic dissolution. An anodic potential of 0 mV vs. SCE seems to have

also a degrading effect on the fatigue life at $\sigma_a = 400$ MPa as it reduces the number of cycles to failure to 6.7% compared to samples tested in air. The E_R and E_p values are adopted from our previous paper on SCC of Vitreloy 105 in the same chloride-containing electrolyte (Gostin et al., 2015a). At an elevated load level of $\sigma_a = 600$ MPa for the -50 mV vs. SCE polarized samples, the fatigue lifetime is $15,110 \pm 10$ cycles (average value), which is five times longer than in air. However, the mean fatigue lifetime in non-halide 0.01 Na_2SO_4 solution under open circuit conditions is $2,560 \pm 10$ cycles and, therefore, slightly below the fatigue life in air. Consequently, the applied potential of -50 mV vs. SCE seems to have a further beneficial effect on the forming of the presumed oxide layer within the crack. At $\sigma_a = 200$ MPa, all non-polarized samples passed the limit of 10^5 cycles while anodic polarization at $+50$ mV vs. SCE caused failure after $1,380 \pm 10$ cycles due to intense anodic dissolution processes. The damage-provoking mechanisms are suspected to be mechanically as well as corrosion driven. This should be clarified by a comprehensive SEM analysis with additional EDX in the following part of the manuscript.

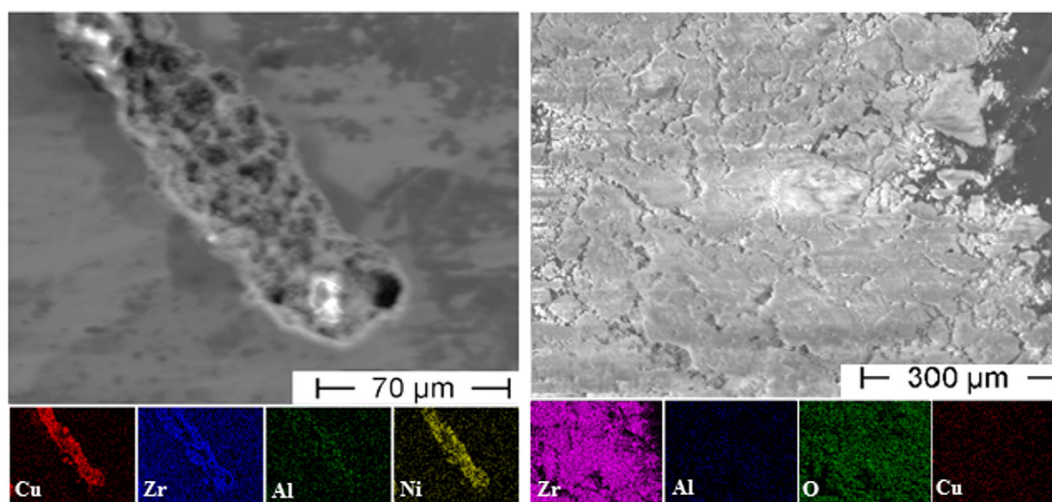
FIGURE 8 | Energy dispersive X-ray analysis of a corrosion pit at the side surface of the bending sample (left) and of the dissolved material extracted from the electrolyte as powder after testing (right).

The onset of anodic dissolution could be determined easily during CF testing under potentiostatic control. Characteristic corrosion products developed at the crack tip and spread out quickly. After the experiment, it was possible to gather the dissolved material in form of fine powder at the bottom of the electrochemical cell and to extract it from the residual electrolyte. This powder was investigated by EDX as well, and the results are shown in **Figure 8** (right). As expected, it consists basically of Zr and O while only traces of Cu could be detected. However, the fraction of Al seems to be smaller than expected due to the results from the corrosion pit, but this element could be detected poorly overall.
